Cerbo GX Wi-Fi issues when combined with GX Touch

Tech note – March 2021 – v2

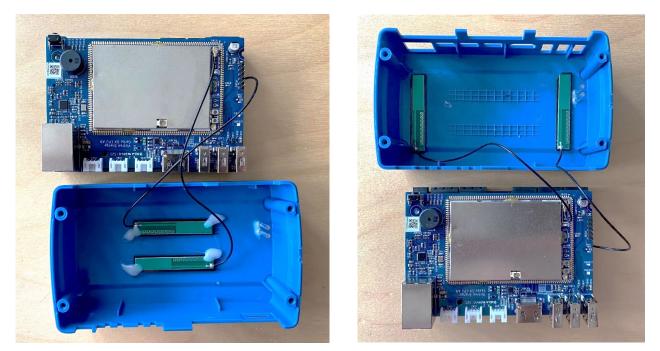
The cause is a hardware design issue in the Cerbo GX. The Wi-Fi client¹ antenna cable in the Cerbo GX is routed too close to the HDMI connector. The HDMI signal disturbs Wi-Fi communication on Wi-Fi channels 1, 6, 7, 8, 9 and 13. All other channels, 2, 3, 4, 5, 10, 11 and 12, work fine. The antenna cable is loosely routed inside the Cerbo GX-es, worst case it will touch the PCB or the connector. In other cases, it is routed a bit further away and will prove to be no issue on said Wi-Fi channels.

Left picture 1. Antennas in the original location. Blue part at the bottom is the top of the case upside down. Right picture 2. Antennas in the new location.

Step 6: move the blue part of the case to be above the unit (as per picture on the right) and then mount the antennas as shown in that picture. Some new glue might be needed, though on all units we have seen the double-sided tape was still more then sticky enough to keep the antennas in place. Make sure not to cover the antenna completely in glue; less glue on the antenna is better.

Step 7: insert the electronics back into the case, while making sure the antennas stay away from the HDMI connector and the area around it. Ca 1 cm away is sufficient – further away is better. Check that everything properly aligns – including the SD-Card slot; and finally remount the bottom of the case.

The new position of the antennas has proven to be better in signal quality in general. It also prevents both the antenna cables to be within a few centimetres of the HDMI area.
