Summary

Some MultiPlus-II, EasySolar-II and Quattro-II inverter/chargers can, when newly installed, have an issue with the Current Sense socket. Due to a mechanical fault, the inverter will read wrong values for the AC input current.

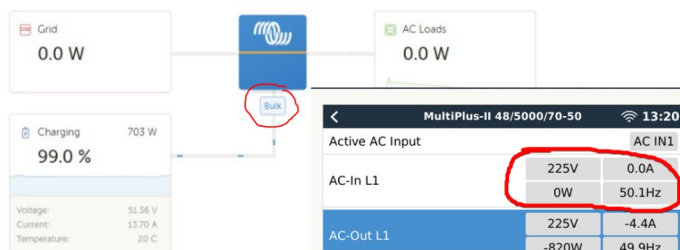
- The AC-input (Grid) reading on the GX and on VRM stays at '0.0 W' or indicates an incorrect value.
- The AC Loads show '0.0 W' on the GX and on the VRM dashboard while in fact there is a load connected.
- The unit will not charge the batteries, although the charge Led's on the cover indicate the unit is charging.
- When the MP-II is in charger mode, it does not show the charge values on the GX device or on the VRM Dashboard.
- In an ESS system without external grid meter the unit will behave unpredictable feeding back in the grid -or not- and will show strange values.

Picture left showing incorrect data on (CC)GX and the VRM Dashboard.

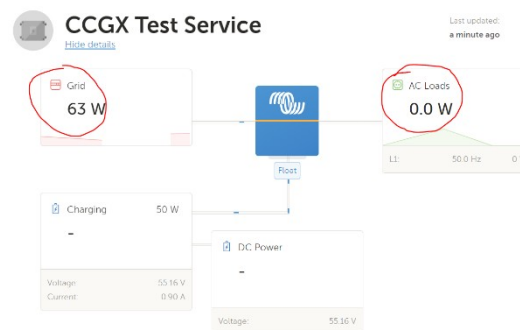
Picture right showing 0.0W AC Loads and 63W consumed power from the grid. In reality a 600W load is connected!

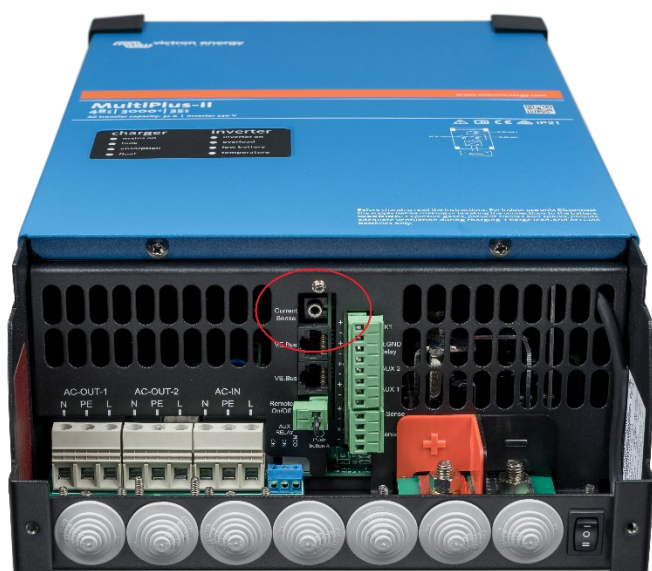
The cause is a hardware issue with the "Current Sense" socket on the bottom side of the unit. When an external current sensor is connected, the internal one is disconnected through this connector. Sometimes the contact inside this connector gets 'stuck' due to heat during the production of the board.

Picture of the connections of the MultiPlus-II. Encircled the Current Sense socket.

Insert a 3.5mm jack plug a couple of times and remove it again. E.g. an (old) headphone plug should work. This releases the 'stuck' connector and making it properly register that a plug is -not- inserted.

Step 3: insert a 3,5mm jack plug (any 3.5mm jack plug will do the trick, e.g. an old headphone or audio plug) a couple of times in the Current Sense socket to 'reset' the connector. Do not leave the plug in the socket, always make sure to remove it.
