# MultiPlus-II/EasySolar-II/Quattro-II Current Sense socket issue

Tech note – December 2021 - rev 3

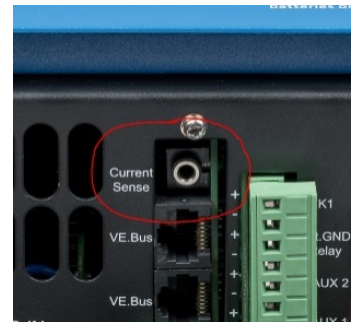
And lastly, in all above mentioned cases the real power from/to the grid will have no relation with the power displayed on the GX, VRM Portal, VictronConnect App or VEConfigure. The displayed power will likely (but not necessarily) stay at 0 W and 0 Amps.

Picture left showing incorrect data on (CC)GX and the VRM Dashboard.

To fix the contact, first switch the unit off and then briefly insert a 3.5mm jack plug (standard old style headphone plug) in the connector. Remove and re-insert the jack plug a few times to clear the issue. Finally, remove the jack plug and switch the unit back on. The problem is now resolved.

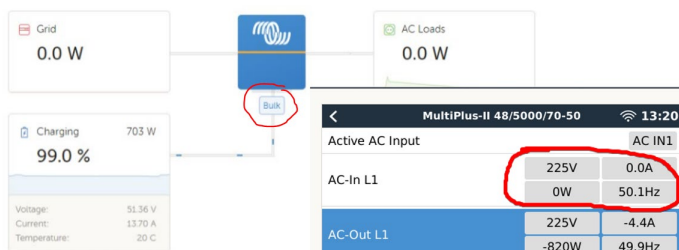
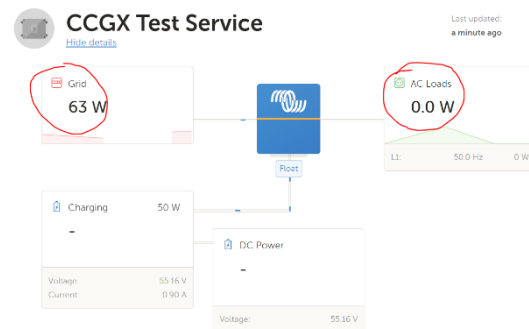
Picture right showing 0.0W AC Loads and 63W consumed power from the grid. In reality a 600W load is connected.

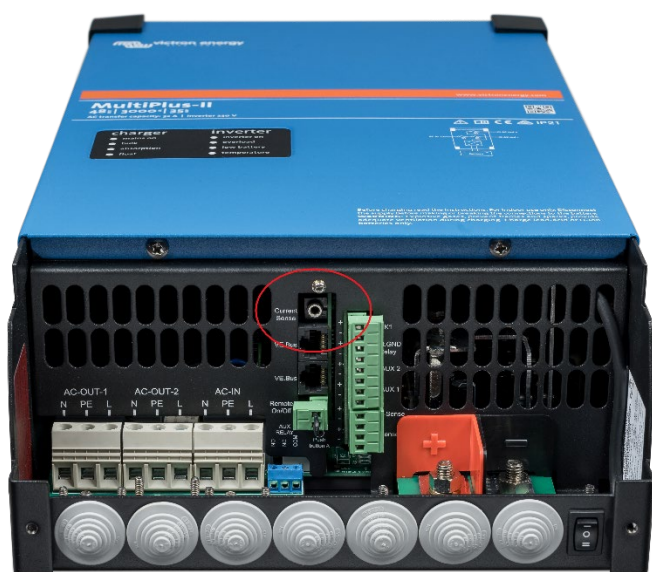
The background: in the socket, there is a mechanism that electrically connects the internal current sensor to the measurement circuitry. Inserting an external current sensor breaks that connection and makes it use the external current sensor instead. The problem is a bad contact when there is no external current sensor inserted.

*Picture of the connections of the MultiPlus-II. Encircled the Current Sense socket.*

Step 1: turn the I-O-II switch, see lower right in below picture, to the '0' (Off) position.

Step 2: open the black connection cover by unscrewing the two screws at the bottom.

Step 3: insert a 3,5mm jack plug (any 3.5mm jack plug will do, also when connected to a headphone), and remove it. Do this a few times. Then remove the plug.

Step 4: Turn the unit 'On' and check on your GX device and/or on the VRM dashboard to see if the AC-input current is showing the correct values.
