MultiPlus-II/EasySolar-II/Quattro-II Current Sense socket issue

Tech note – December 2021 - rev 3

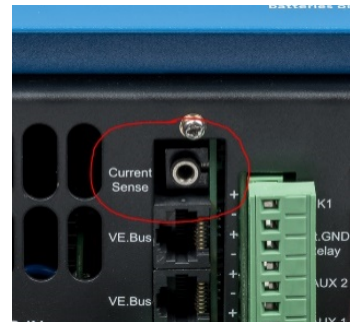
And lastly, in all above mentioned cases the real power from/to the grid will have no relation with the power displayed on the GX, VRM Portal, VictronConnect App or VEConfigure. The displayed power will likely (but not necessarily) stay at 0 W and 0 Amps.

Picture left showing incorrect data on (CC)GX and the VRM Dashboard.
